**CANADIAN FORCES  
FLIGHT SAFETY INVESTIGATION (FSI) REPORT (FSIR)**

**FINAL REPORT**

**FILE NUMBER:** 1010-12422 (DFS 2-4-2)  
**DATE OF REPORT:** 11 Mar 2003  
**AIRCRAFT TYPE:** CH124A Sea King  
**DATE/TIME:** 23 2224Z/1224 Local June 2000  
**LOCATION:** 19 01N-156 58.5W (150NM South of Pearl Harbor)  
**CATEGORY:** "A" Category Accident

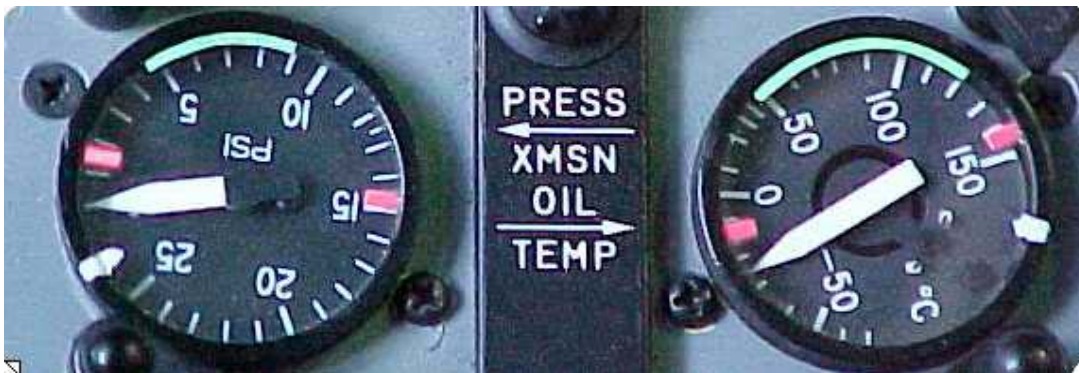
**Figure 1- MGB Oil Temperature and Pressure Gauges**

When the pilot first noticed the "TRANS OIL HOT" caution light, he immediately noted that the MGB oil temperature gauge was indicating 150°C (max reading on

the gauge - see photo at Figure 1- MGB Oil Temperature and Pressure Gauges). Given that the gauge reading exceeded 150°C before the "TRANS OIL HOT" light illuminated, it is assessed that the cooler was working normally and was simply unable to reduce the temperature of the MGB oil below 120°C. QETE reports that the oil cooler is capable of cooling transmission oil by approximately 30°C. Therefore, if the cooler had failed and un-cooled oil was circulated from the sump past the caution light sensor, the temperature on the gauge would have read approximately 120°C when the "TRANS OIL HOT" light first illuminated instead of the indicated 150°C.
